PRODUCT NOTICE

Logix Designer Ladder Logic Editor Missing All Rungs in a Routine when Online with Correlation after Online Edits are removed in ControlLogix 5580 and CompactLogix 5380

Reference: 2017-10-002

Date: October 2017

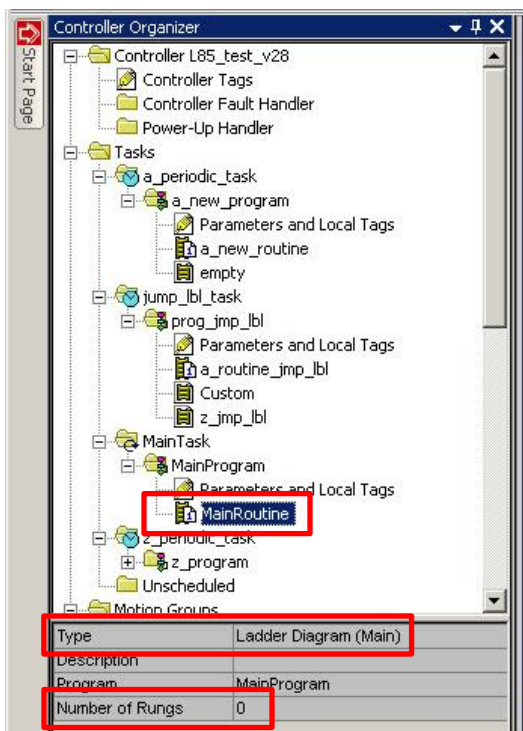
If you are not sure if you are affected by this anomaly, you may inspect your program for all ladder logic routines with zero rungs. Within Logix Designer, open the Controller Organizer and view the properties of each ladder logic routine. Those that show “Number of Rungs – 0” may be affected by this anomaly. A person with knowledge of the program should review all zero rung routines to determine if they may be affected by this anomaly.

In the Controller Organization example shown to the left, the “MainRoutine” routine is of type “Ladder Diagram” and shows “Number of Rungs” to be zero. This routine should be reviewed to determine if it has been affected by this anomaly.

If this condition has already occurred and you have not downloaded the program with the missing rungs to the controller, you may upload the original program from the controller to a new Logix Designer project to recover the missing rungs.
